*Worldwide repairs carried out with PolymerMetal®*

**REP-# 099**

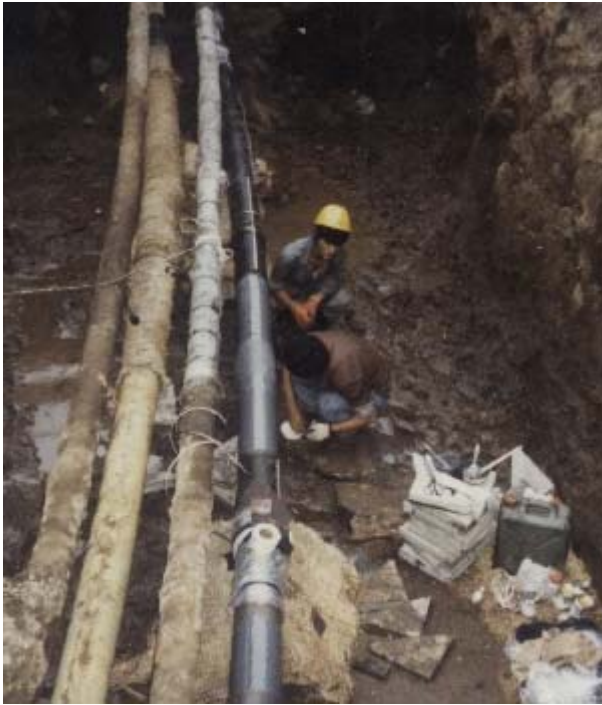
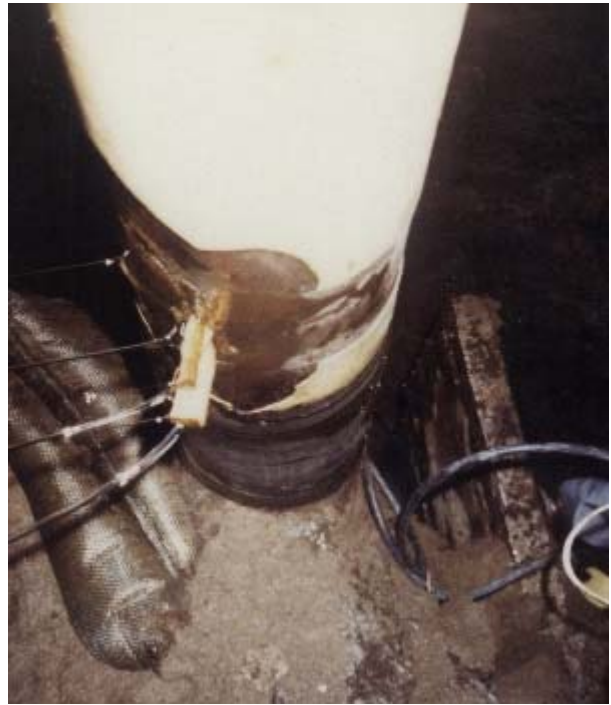
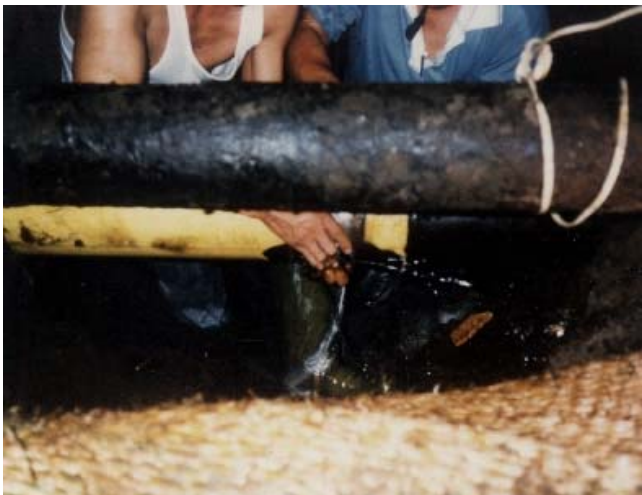
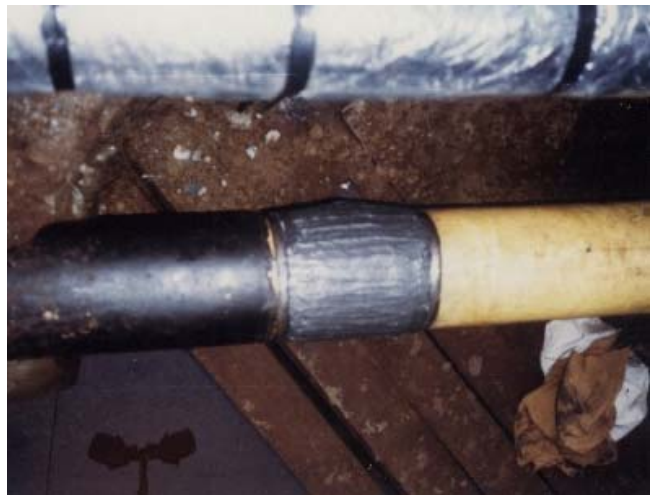
A leakage in a 154 KV P.O.F. insulation pipe was sealed using MM-metal oL-steelceramic and Hardener red working with the Direct-MM-Bonding method. In addition corrosion damages of the piping were removed by applying MM-metal SS-steel, liquid and Hardener yellow, liquid. Oil pressure 200 psi, diameter of the piping 300 mm, oil quality polybdenum.
