Worldwide repairs carried out with PolymerMetal®

REP-# 040

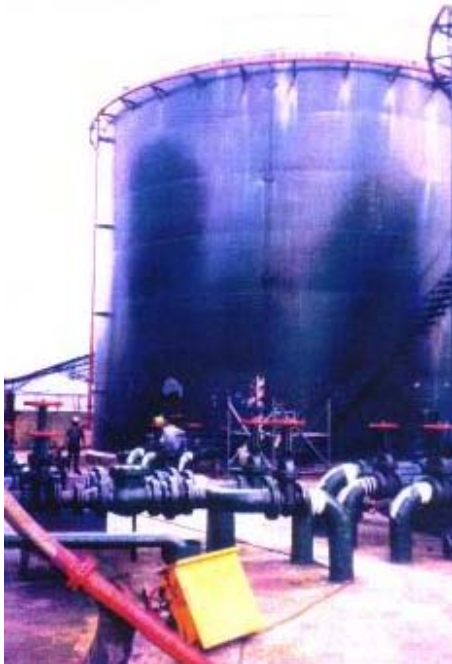
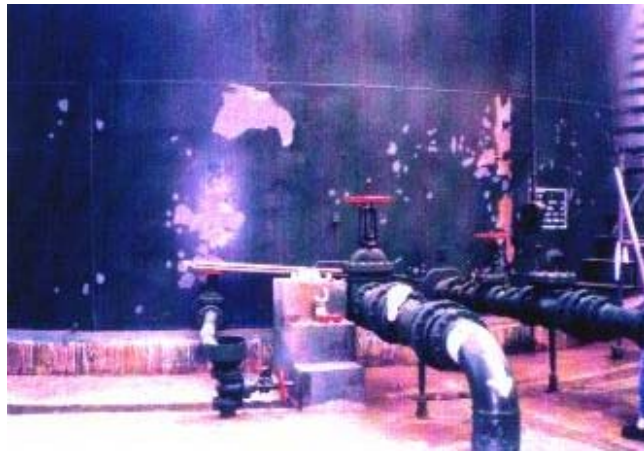
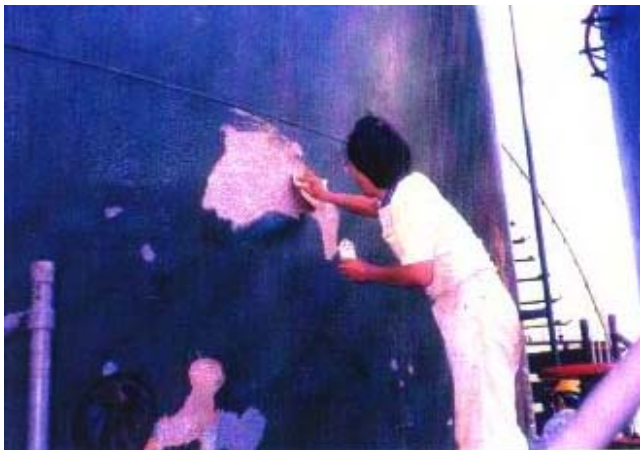
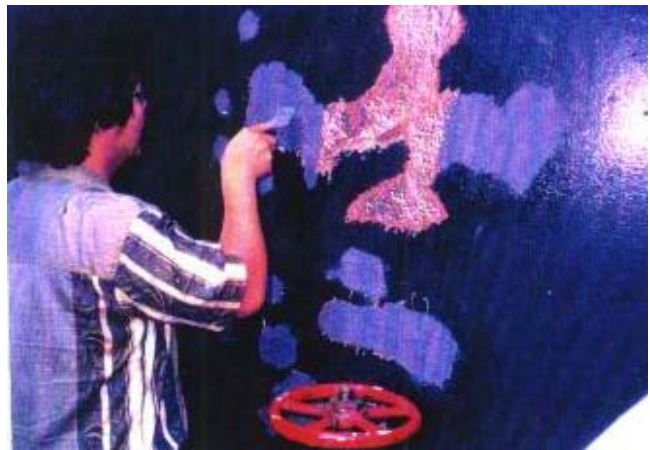
During the maintenance on a fuel/oil storage tank several leakages were noticed. After sandblasting the leakages were sealed by using the Direct MM-Bonding method with MM-metal oL-steelceramic and Hardener red. Furthermore parts affected by pitting were coated by applying MM-metal SS-steel, pasty. 24 hours were needed for the repair works with PolymerMetals, curing time included. The usual repair procedure including emptying of the tanks, cleaning of steel walls and welding would have taken 6 days.
