*Worldwide repairs carried out with PolymerMetal®*

**REP-# 041**

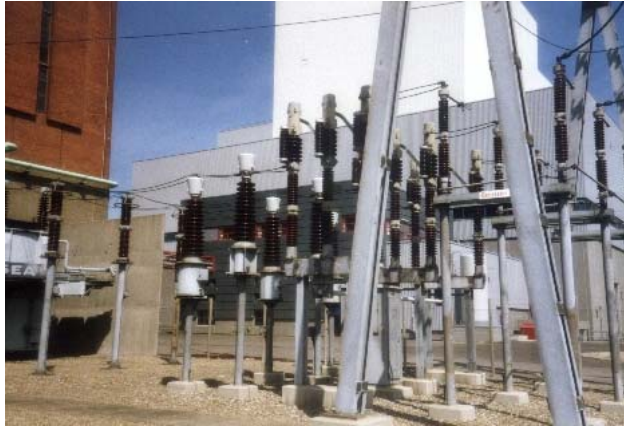
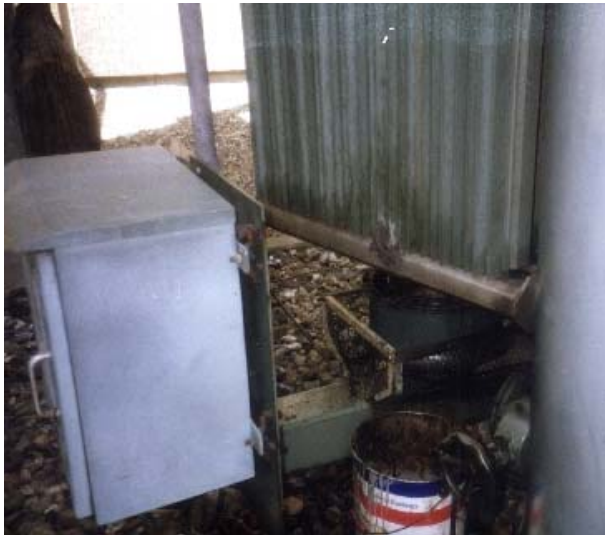
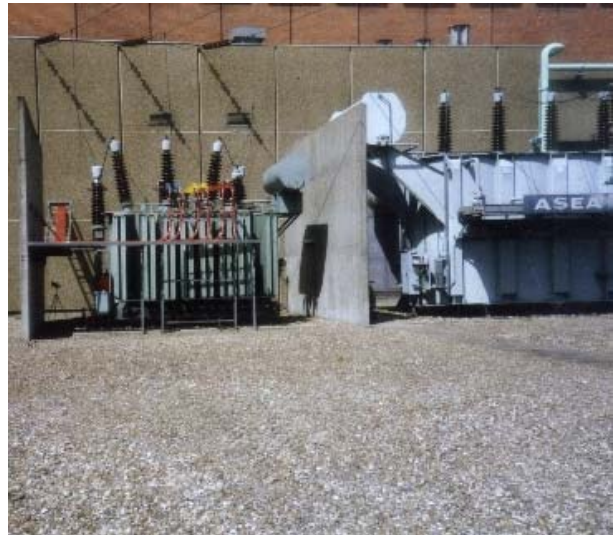
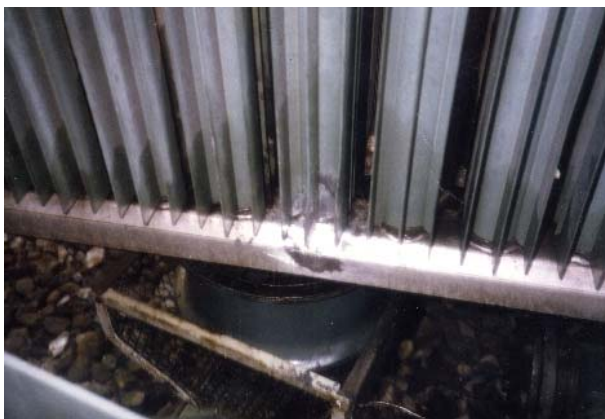
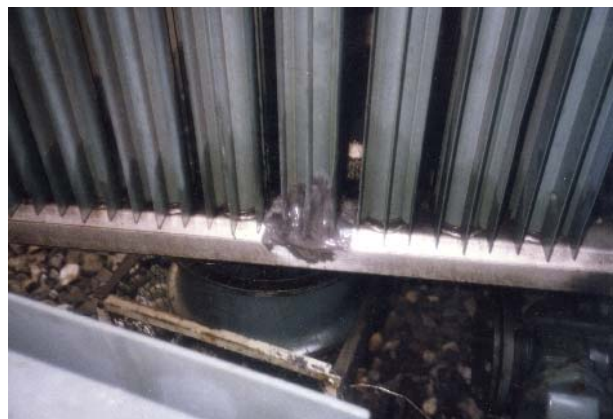
Sealing of a large transformer in a power station. The leakage was sealed with MM-metal oL-steelceramic and Hardener red using the Direct-MM-Bonding method. Then a layer of MM-metal oL-steelceramic and Hardener yellow was applied to the first layer.
